IV THE EVIDENCE OF THE FORGED SNML SAMMELBAND BOOK STRUCTURE

SIDEREUS NUNCIUS

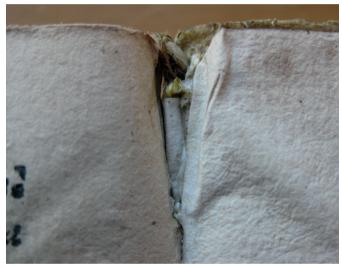
Fig. 6: The sewing thread in the final gathering bypassing sewing station 4.

The final text gathering in the book has a sewing hole against the lowest sewing support on the spine (sewing station 4) which the thread, which is the same as in the rest of the later editions in the book, goes past. The thread shows no evidence of having once been taken through this hole, yet the hole has clearly been used in the past (Fig. 6). This must be the result of some unexplained disturbance of the structure.

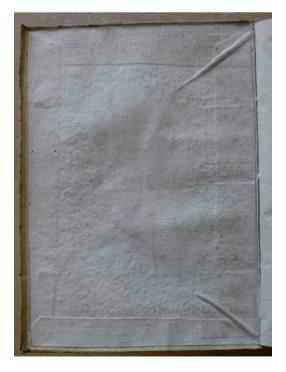
Fig 10: Inside the left and right covers.

The thin cartonnage boards are completely covered by the parchment cover and paper pastedowns and it is therefore not possible to comment on their appearance, beyond saying that the uneven surface shown under the pastedowns is typical for an Italian binding of this sort and age. They do not, however, show the distortion and damage evident on the parchment cover itself, suggesting that they too are not original to the cover (Fig. 10).

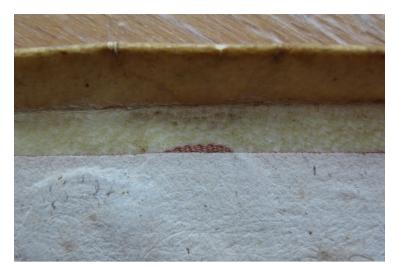
Fig. 11: A portion of a silk tie projecting from under the pastedown inside the right cover.

The fact that both boards have the stubs of silk ties trapped by the pastedowns on their fore-edges would suggest that they belong to the cover, but the cleanness of the broken ends visible though the punched holes in the parchment, and the small exposed portion of the lower tie in the right cover are again not what might be expected in a binding of this age and condition, but might have been contrived to establish a sort of casual authenticity for the binding (Fig. 11).
